Merakeb
Abder

Reporting : 26/09/2013 Overshoot on the ASIC

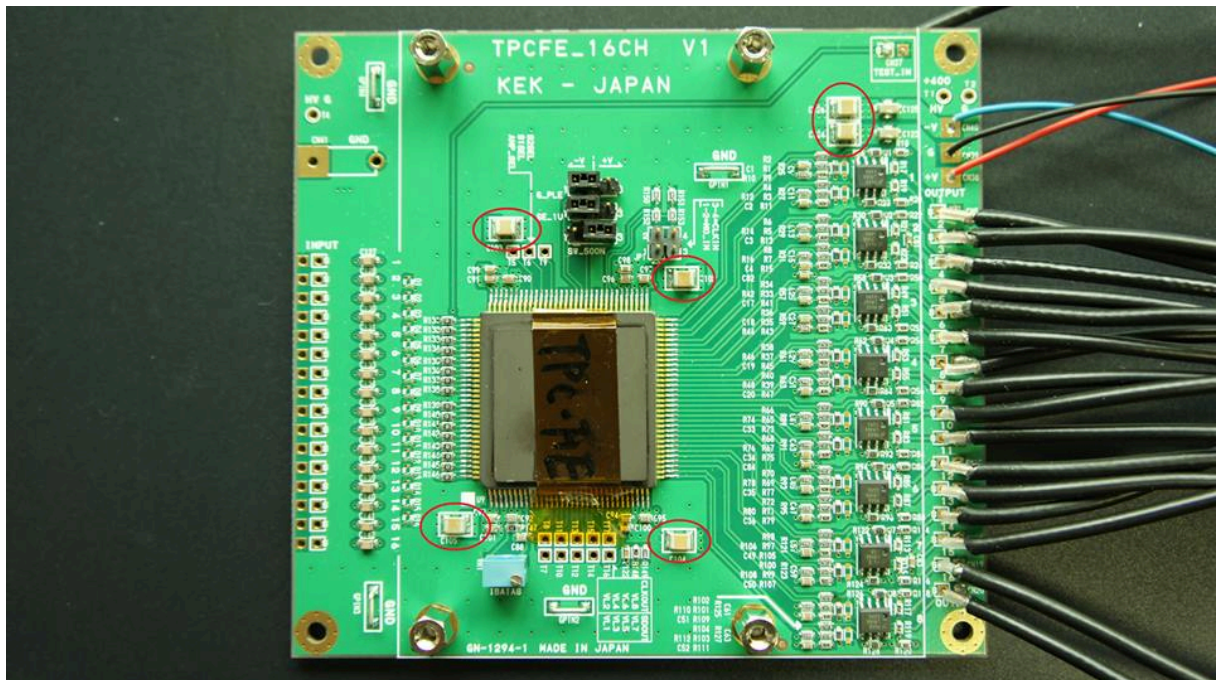
The subatech team proposed then to increase the capacitance of some capacitances responsible of decoupling the current, but the problem remains. (in red the 6 capacitance has been changed into 6.6 micro-fahrad)

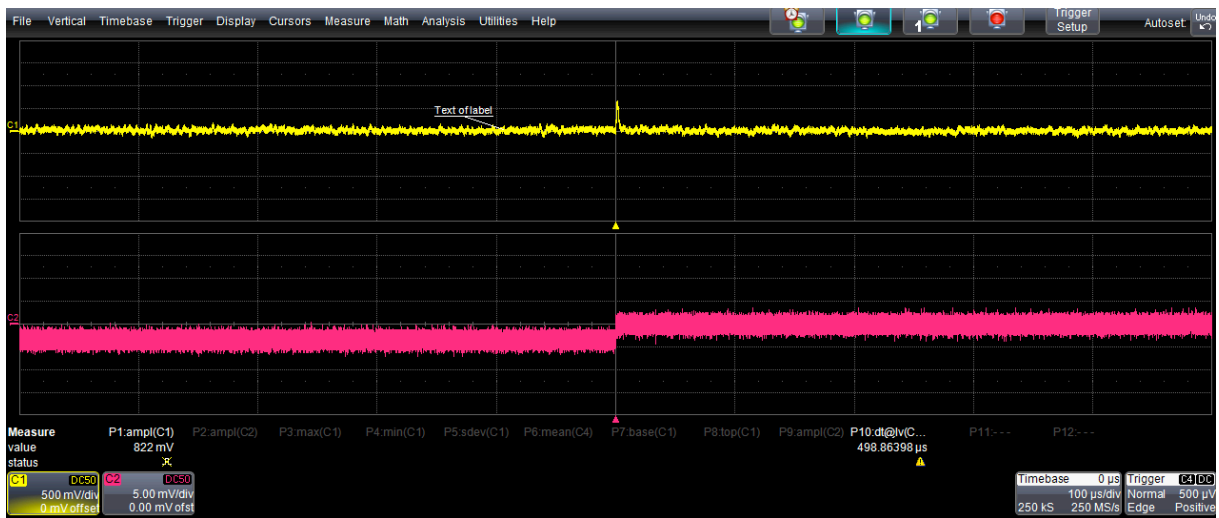
100 micro-second/div

- 1 channel connected ($1 \times 50 \Omega$):

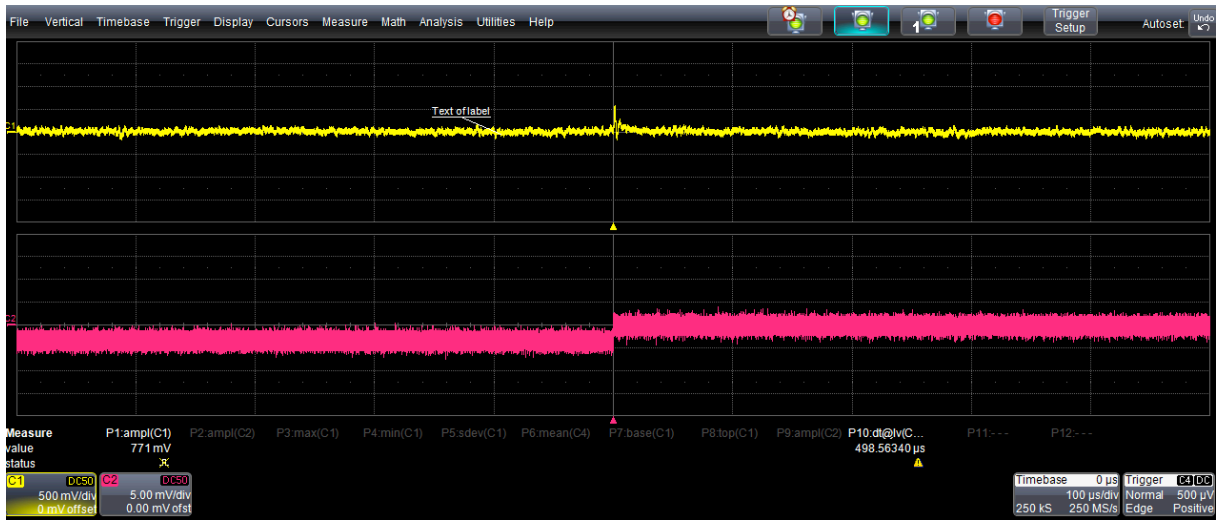
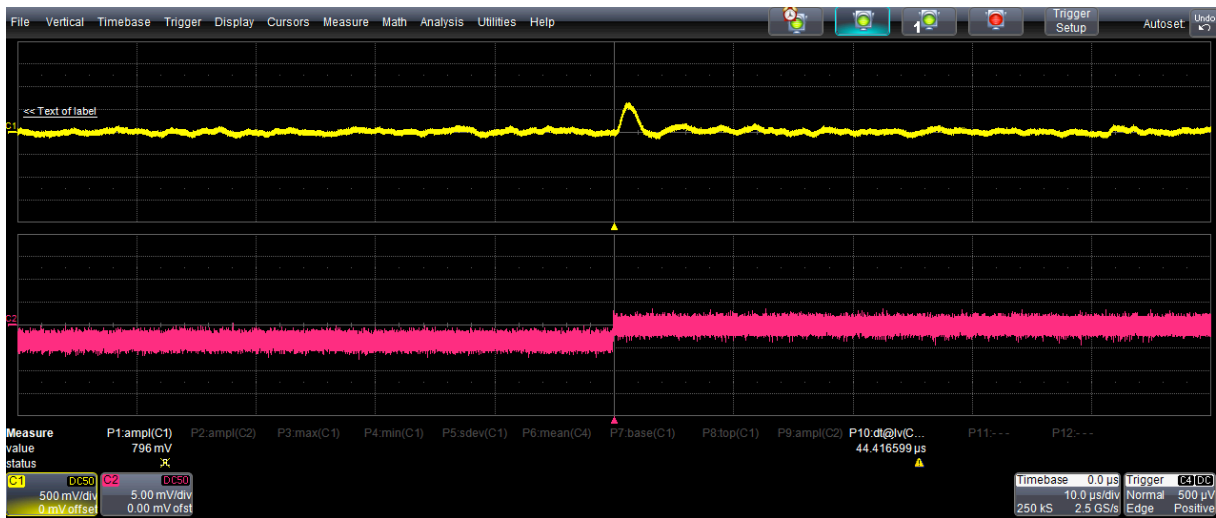
- 4 channel connected (4*50 Ω) :

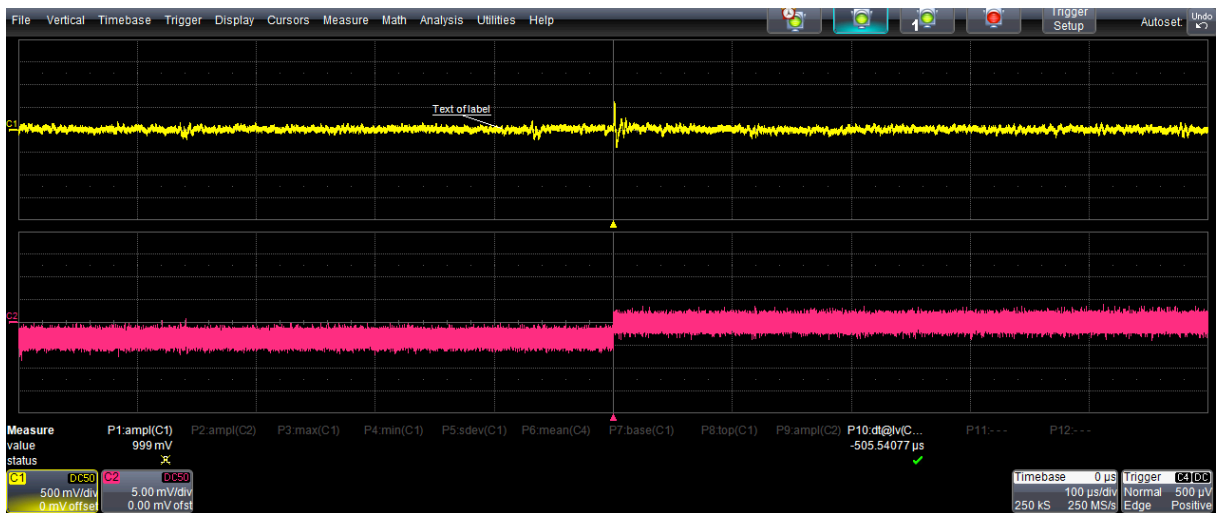
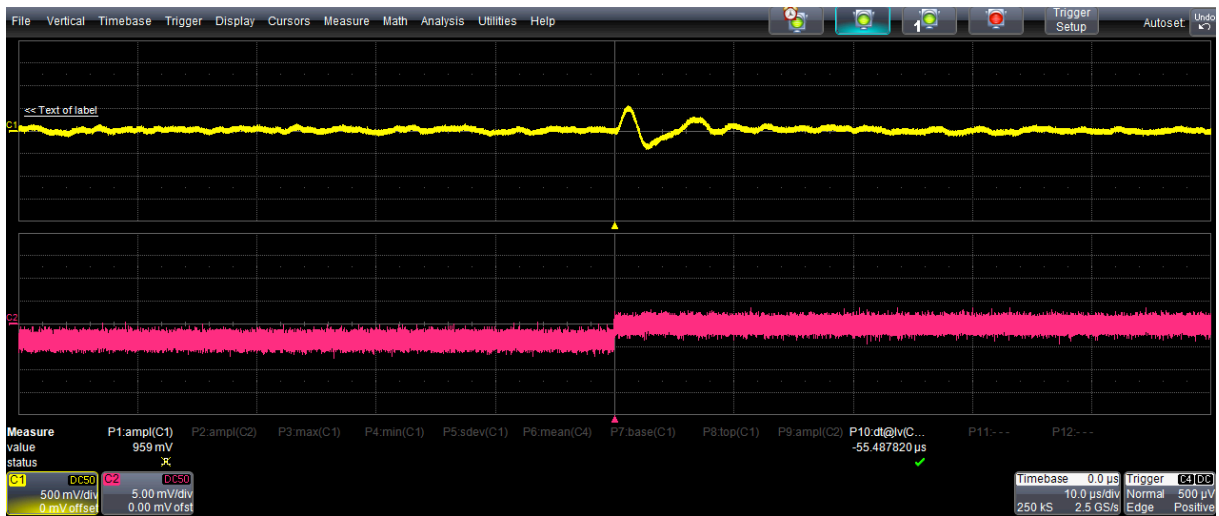
- 8 channel connected (8*50 Ω) :

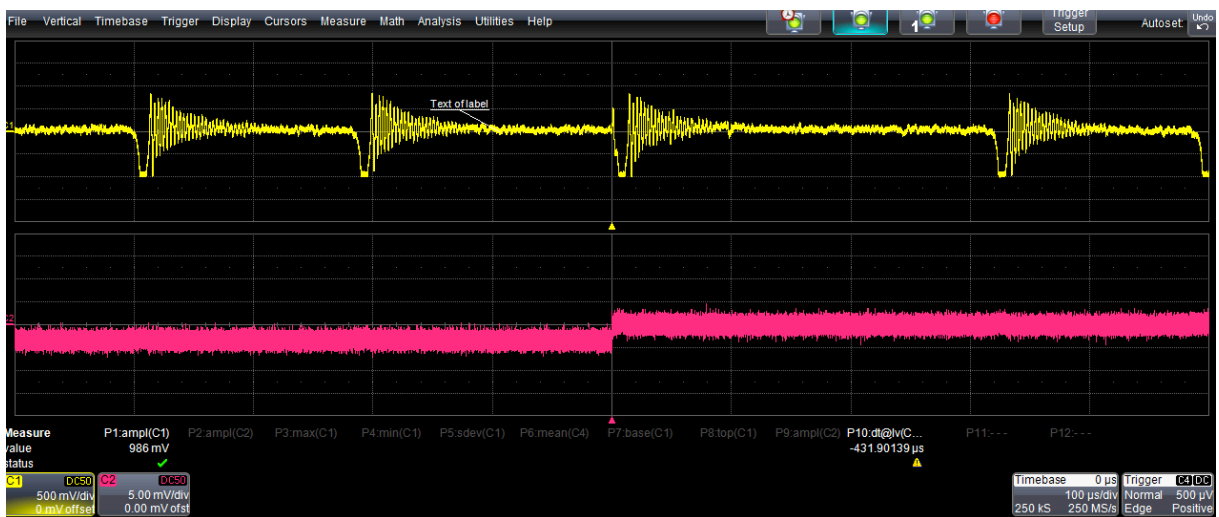
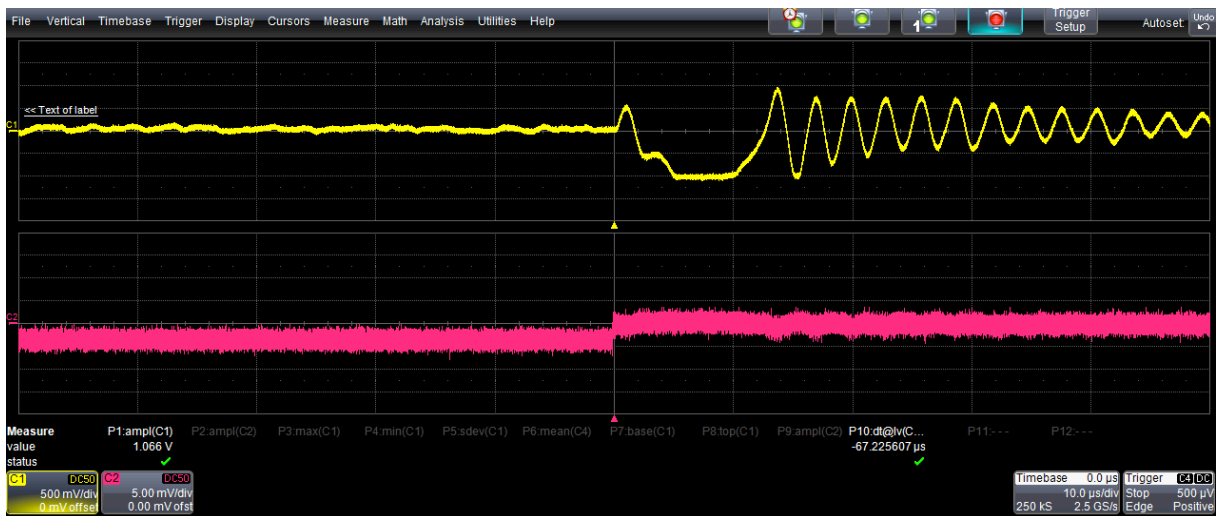
- 12 channel connected ($12 \cdot 50 \Omega$):

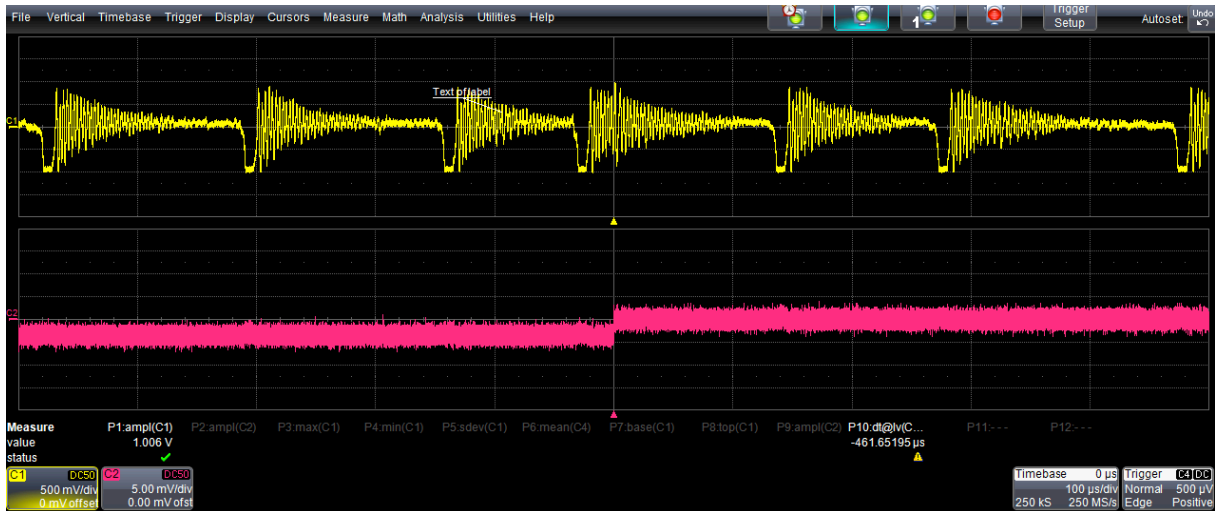
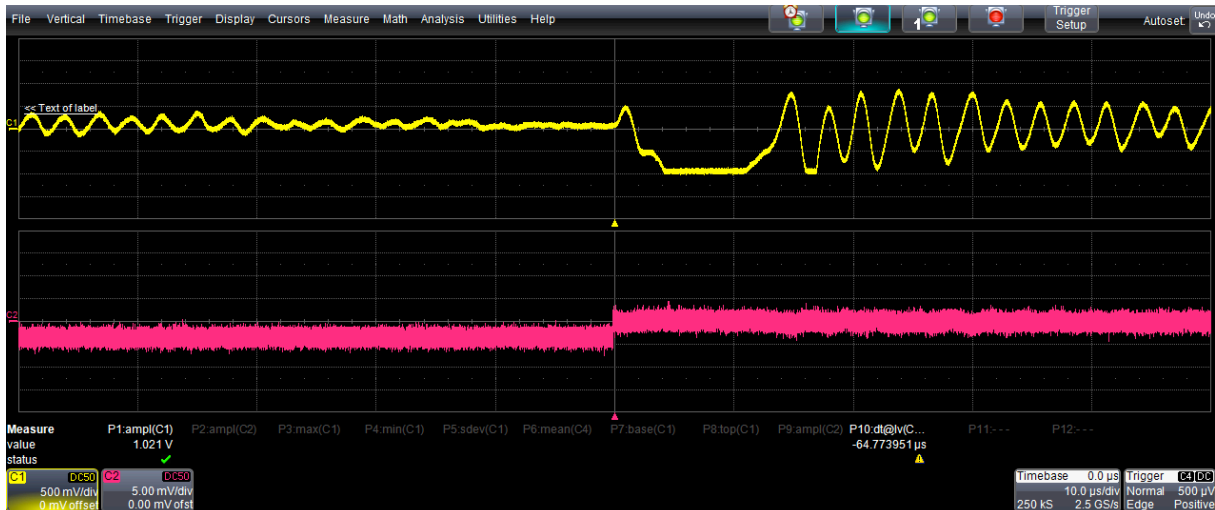
- 16 channel connected (16*50 Ω) :

We can easily have the frequency of the oscillation next the overshoot with the last screenshot:

$$T_{oscill} = \frac{1,3}{5} \times 10 \mu s$$

$$T_{oscill} = 2,6 \mu s$$

$$f_{oscill} = 385 kHz$$
