Identifying high power breakdowns in accelerating structures with acoustic sensors

Nicolas Delerue
GLC Group, KEK

Talk given at the 9th Accelerator and Particle Physics Institute

APPI (Japan), February 2004

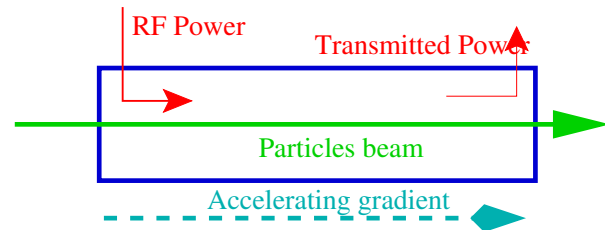
Figure 1: Scheme of an accelerating structure. The electromagnetic wave (red arrows) is inserted at the left of the structure and travels to the right, thus creating an accelerating gradient that will accelerate the particles beam. At the end of the structure the transmitted power is extracted and can be measured.

Accelerating structures are used in (mainly in LINACs) to accelerate particles. Usually a very high frequency (Radiofrequency) electromagnetic pulse is fed into the structure. This electromagnetic pulse will create, in the structure, an accelerating gradient that will accelerate the particles beam (see figure 1).

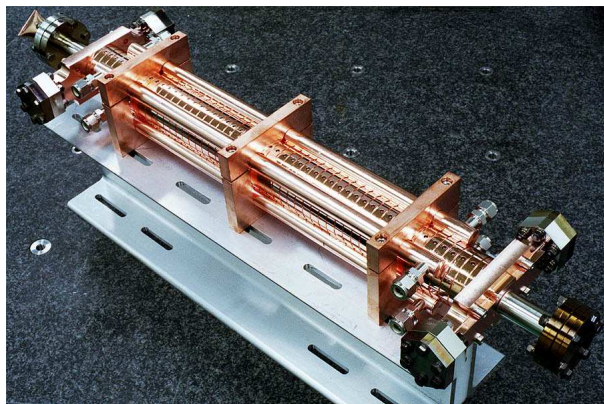
Figure 2: A x-band accelerating structure.

At KEK-B the typical power feed into a structure is 40 MW at 3 GHz (S-band) whereas the structure that should be used in the Linear Collider [1] (if warm technology is chosen) will be fed with 75 MW at a frequency of 11 GHz (X-band). A picture of an X-band accelerating structure is shown

on figure 2.

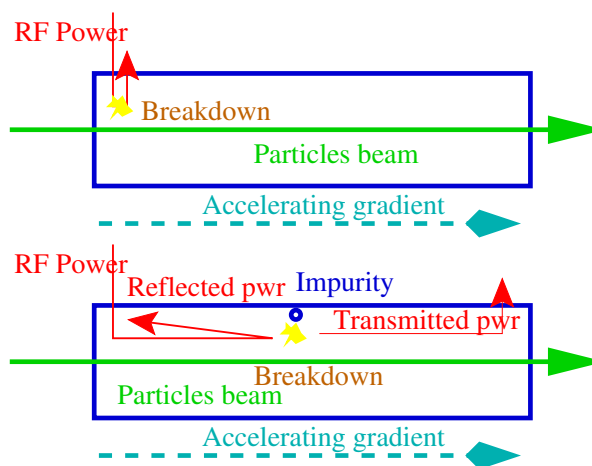
Figure 3: Breakdowns in an accelerating structure. Breakdowns can occur either at the input or output of the structure (top figure) or somewhere else in the structure, for example near an impurity at the surface of the structure (bottom figure). The timing with which power will be transmitted and reflected depends on the location of the breakdown.

When the energy concentrated on a given point of the structure becomes too high a spark will occur. This can happen at a location where, by design, the energy density is very high, like for example the input coupler of the structure (see figure 3 top) but this can also happen at a location where there is an impurity at the surface of the metal forming the structure (see figure 3 bottom).

- As shown on figure 3 when the breakdown occurs the incoming electromagnetic wave is reflected back to the input of the structure. If the breakdown occurs in the middle of the electromagnetic wave, then part of the wave will be reflected whereas the part that had already passed the location of the breakdown will be transmitted. Thus by measuring the shape of the reflected and transmitted waves, it is possible to deduce the location and the time (with respect to the beginning of the wave) at which the breakdown occurred. As the electromagnetic wave is often deformed, this method has a limited precision.

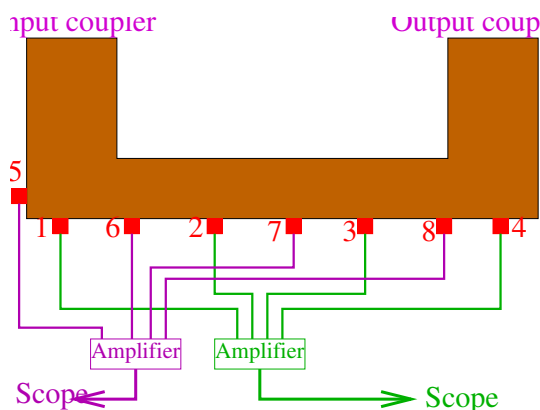
Figure 4: Layout of the 8 acoustic sensors installed on the C-band structure tested at KEK's main Linac.

There is one accelerating structure currently tested at the KEK main Linac. It has been equipped with 4 acoustic sensors, to which 4 extra sensors were added later as shown on figures 4, 5 and 6. Additionally after each breakdown informations about the RF wave are stored and available for analysis.

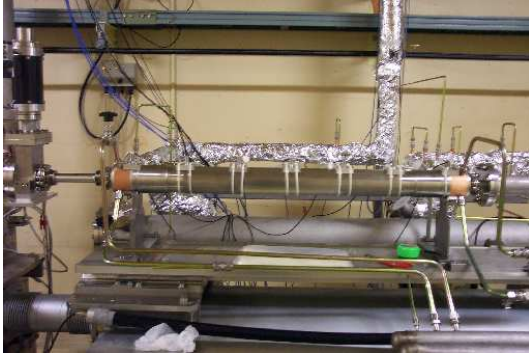
Figure 5: The C-band structure tested at KEK's main Linac. The acoustic sensors can be seen on top of the structure.

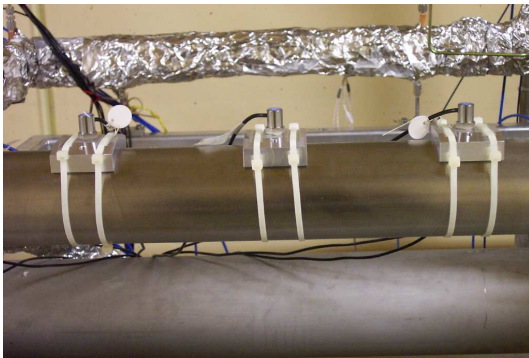
Figure 6: Zoom on 3 sensors installed on top of the C-band structure tested at KEK's main Linac.

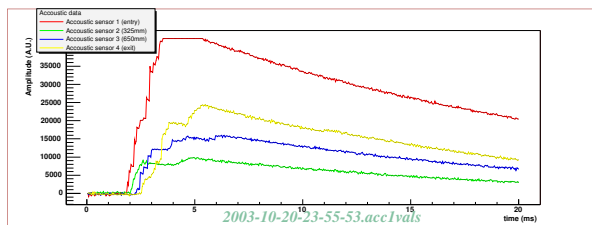
Figure 7: Example of acoustic data recorded during a breakdown at the C-band test stand. Each line corresponds to the noise recorded by a different sensor.

On figure 7 one can see an example of breakdown as recorded by the acoustic sensors. The signal is huge and thus easily distinguishable from the background noise. But extracting the breakdown location from this signal is not so easy. One could decide that the sensor the closest from the breakdown will receive the signal earlier (the travel path is shorter) or the more intense (the attenuation should be smaller).

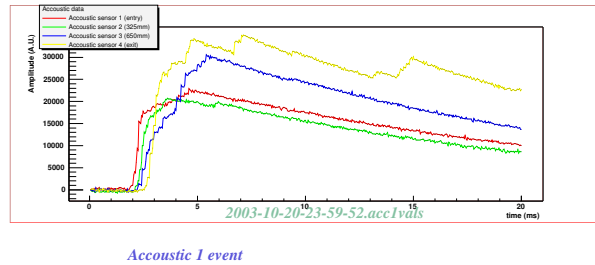
Figure 8: Example of acoustic data recorded during a breakdown. On this event one can see that the sensor receiving the signal first is not the one that receives the most intense signal.

Unfortunately on some events such as the one shown on figure 8 the sensor receiving the signal first is not the one that receives the most intense signal. Furthermore the order in which the sensors receive the signal will not always have a physical interpretation. Thus a double algorithm has been used to locate the breakdown: one is based on the time at which each sensor has received the signal and the other one is based on the intensity of the signal. Attempts to use either intensity or timing information to locate the breakdown between two sensors have not been successful.

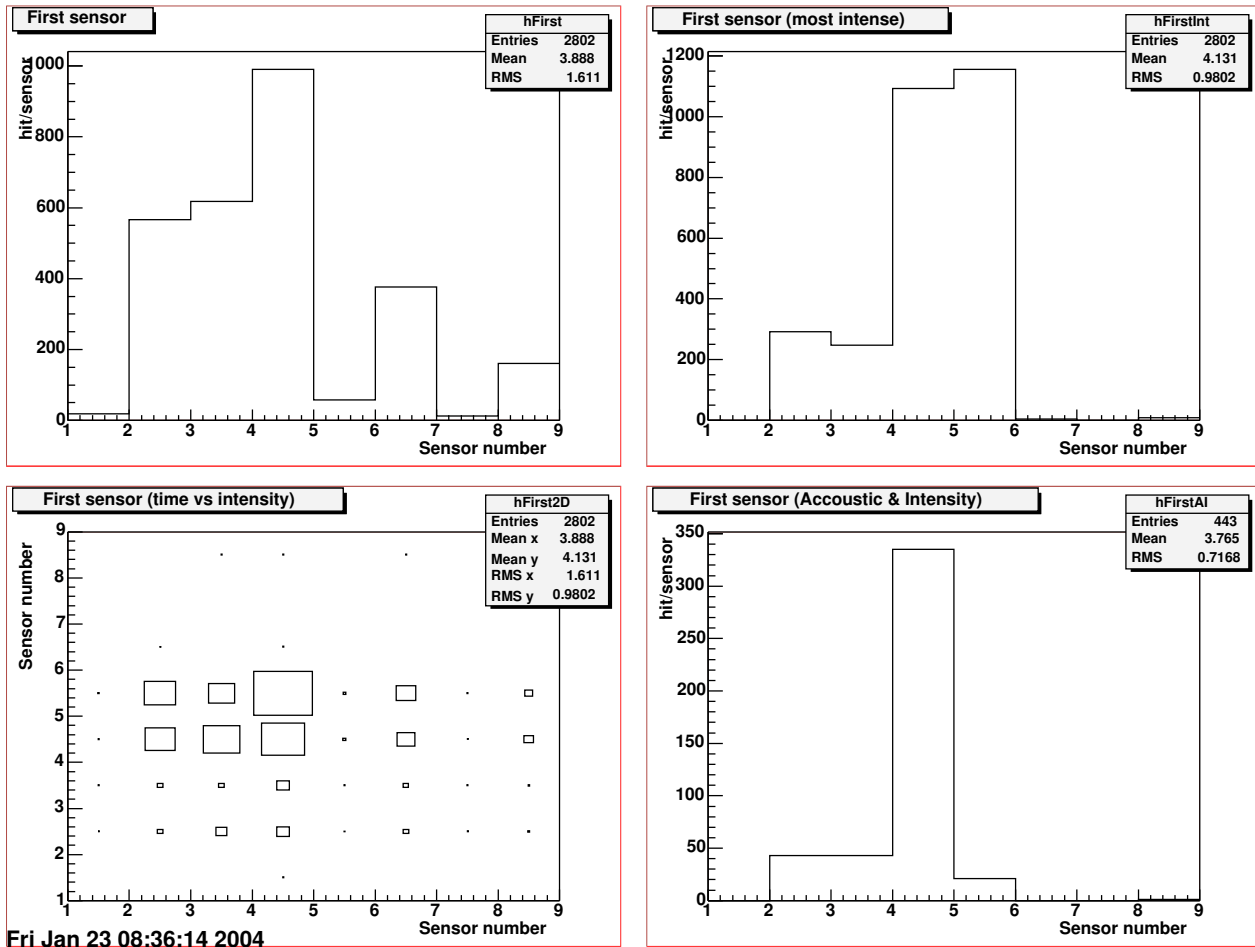
Figure 9: Analysis of the breakdowns recorded with the acoustic sensors. The upper left plot shows for each sensor the number of breakdowns where this sensor received the noise first. The upper right plot shows for each sensor the number of breakdowns where this sensor received the most intense signal. The lower left plot shows the correlation between the two upper plots, the horizontal axis corresponding to the sensor that received the noise first and the vertical axis to the sensor that received the most intense signal. The lower right plot shows for each sensor the number of breakdowns where this sensor received the signal first and also received the most intense signal.

The number of breakdowns recorded by each sensor can be seen on figure 9. The upper left plot shows the number of breakdowns that have reached a sensor first, the upper right shows the number of breakdowns that were the most intense for a given sen-

sor. The lower left plot shows the correlations between the two upper plots and the lower right plot shows when the number of breakdowns when timing and intensity information agree (golden events).

From this figure one can see that the breakdowns occur in the forward region of the structure as sensor 2 to 4 record the most intense signal. By looking at the golden events one can see that these events seems to be located inside the structure rather than at its edge as it is sensor 4 that records the more golden events.

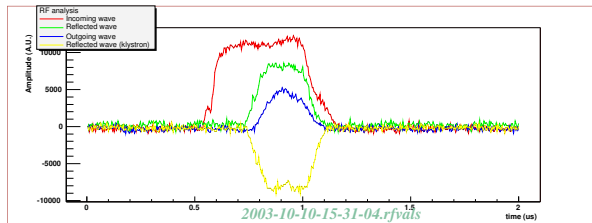
Figure 10: Example of RF data recorded during a breakdown. The red line corresponds to the incoming RF wave, the green line to the reflected RF wave, the blue line to the outgoing wave and the yellow line to the reflected wave at the klystron..

The analysis of the electromagnetic waves is more straightforward. The figure 10 shows an example of electromagnetic wave measurement during an event where a breakdown occurred. The difference between the time at which the outgoing wave (in blue) finishes and the time at which the reflected wave (in green) reaches the input of the structure provides information on the location of the breakdown: if the breakdown occurred close from the output of the structure the outgoing wave will have to

travel a much shorter distance than the reflected wave, thus the time difference between the two will be negative. On the other hand, if the breakdown occurs near the input coupler the reflected wave will have a short travel distance whereas the outgoing wave will have to travel a much longer path, thus the difference will be positive.

The comparison between the length of the incoming electromagnetic wave and the length of the outgoing wave gives the time at which the breakdown occurred.

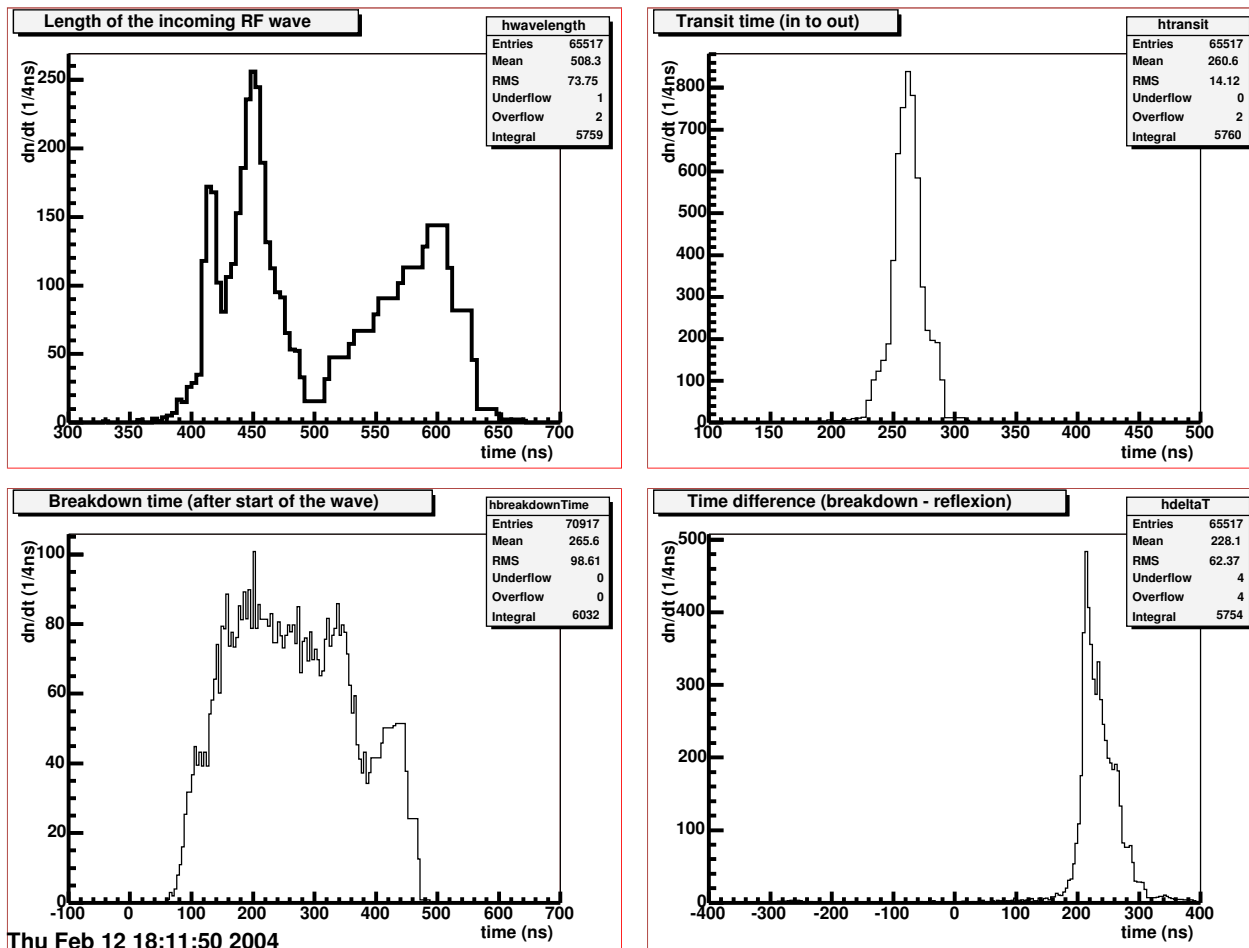
Figure 11: Analysis of the electromagnetic waves information recorded with each breakdown. The upper left figure shows the total length of the incoming RF wave. The upper right plot shows the transit time from the input to the output of the coupler. As this time is a constant the width of the peak gives the resolution of our measurement. The lower left plot shows the breakdown time after the start of the wave. The lower right plot gives the difference between the time at which the outgoing and reflected waves were recorded. Positive values correspond to breakdowns near the input kicker.

To measure the resolution of this analysis, it is possible to look at the difference between the time at which the incoming wave is recorded and the time at which the outgoing wave is recorded. This difference corresponds to the time an electromagnetic wave needs to travel the length of the structure and should be constant. The distribution of this variable gives the resolution of the other variables.

The analysis of the electromagnetic waves information is shown on figure 11. From this analysis one can see that there is no specific time at which the breakdown occurs but that almost all breakdowns occur near the input coupler.

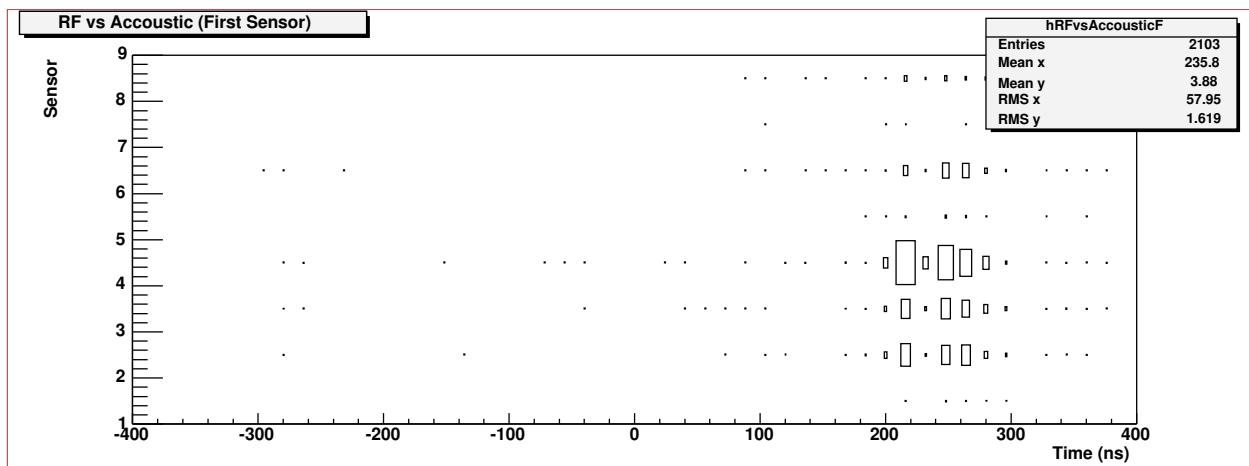
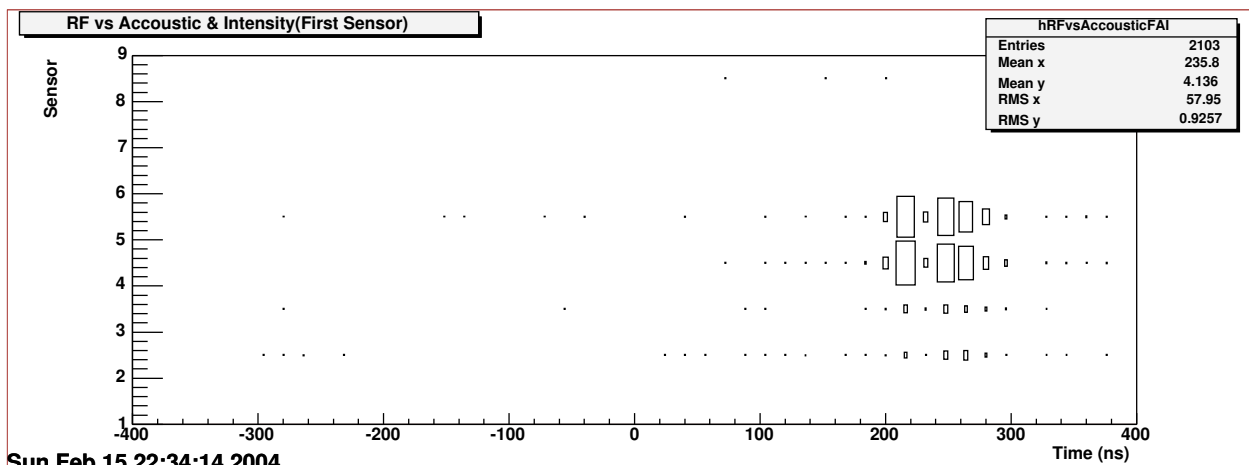
Figure 12: Correlations between the acoustic sensors analysis (vertical scale) and the electromagnetic waves analysis (horizontal scale).

The correlation between the information collected with the acoustic sensors and the electromagnetic waves analysis has been studied. This correlation can be seen on figure 12.

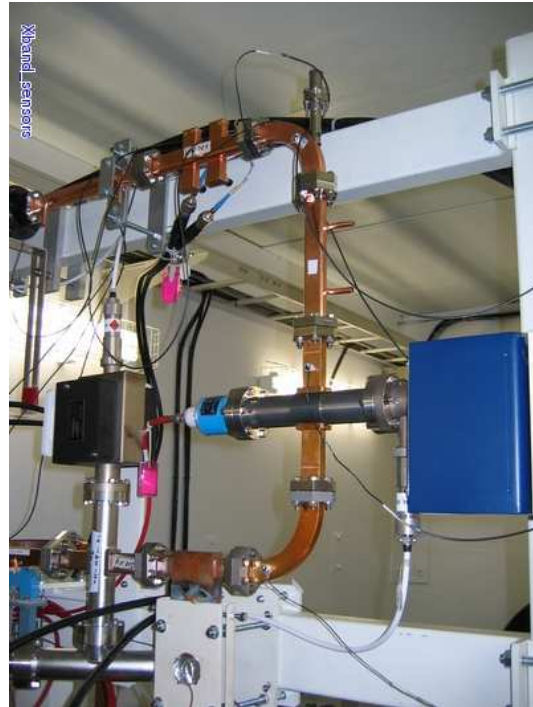
Figure 13: A waveguide of the X-band test stand equipped with acoustic sensors.

A usual glue was used to stick the acoustic sensors on the waveguides at the location known to be the most likely to produce breakdowns. Acoustic sensors glued on the waveguides can be seen on figures 13 and 14.

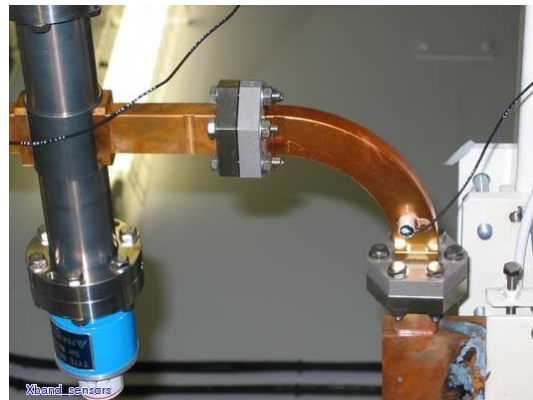
Figure 14: A piece of waveguide of the X-band test stand with an acoustic sensor.

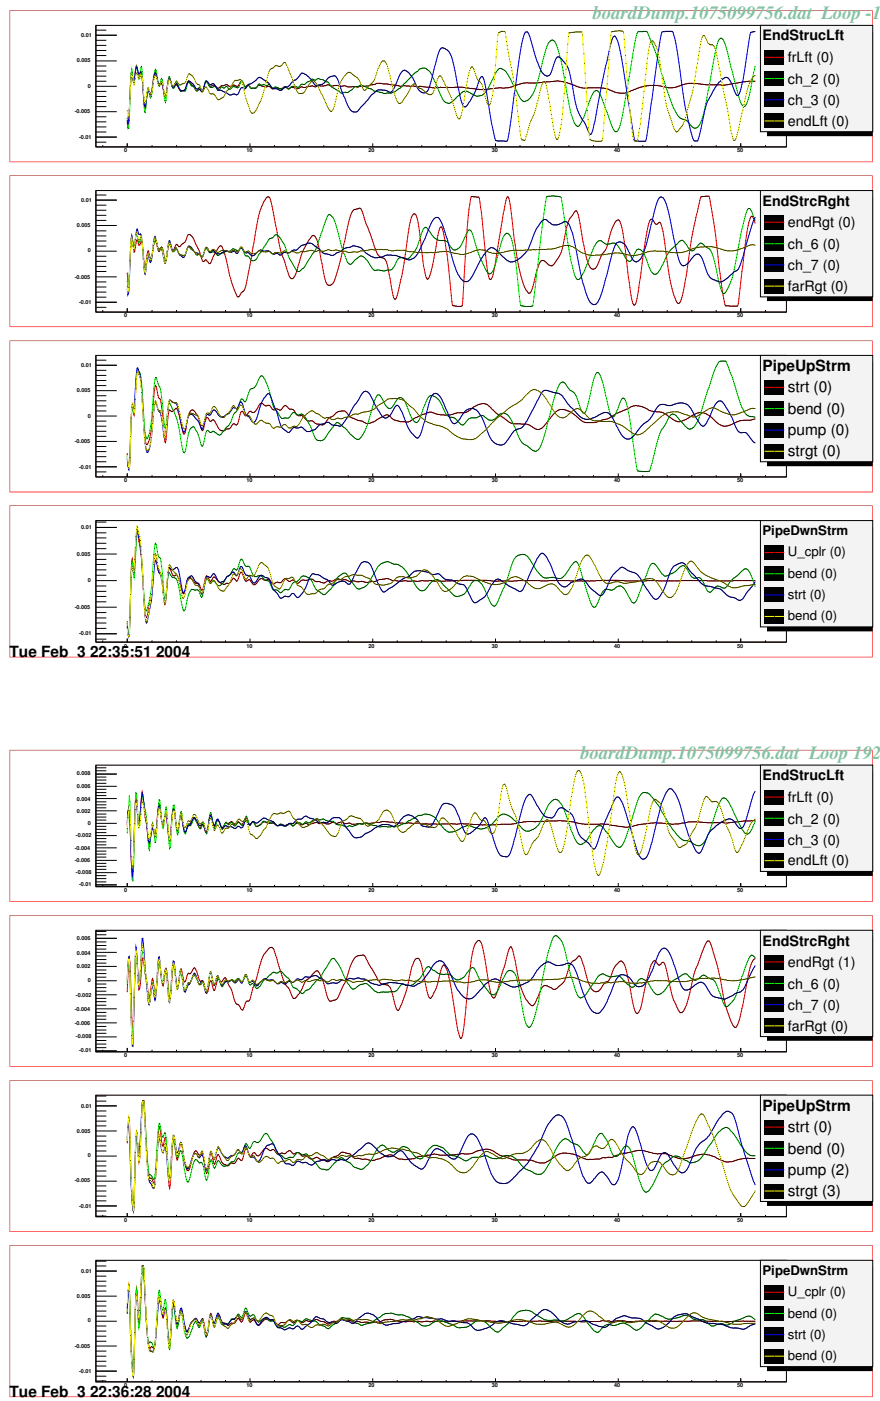
Figure 15: X-band events. On the top figure there is a breakdown on the 4 upper channels (upper plot) whereas on the bottom figure the noise recorded does not correspond to an actual breakdown.

The figure 15 page 11 (top) shows a typical event as recorded by the acoustic sensors at

On this event one can see that even before the breakdown there is a lot of noise recorded by the sensor, especially the klystron noise at the beginning of the record. The figure 15 (bottom) shows an example of non breakdown event with high intensity noise.

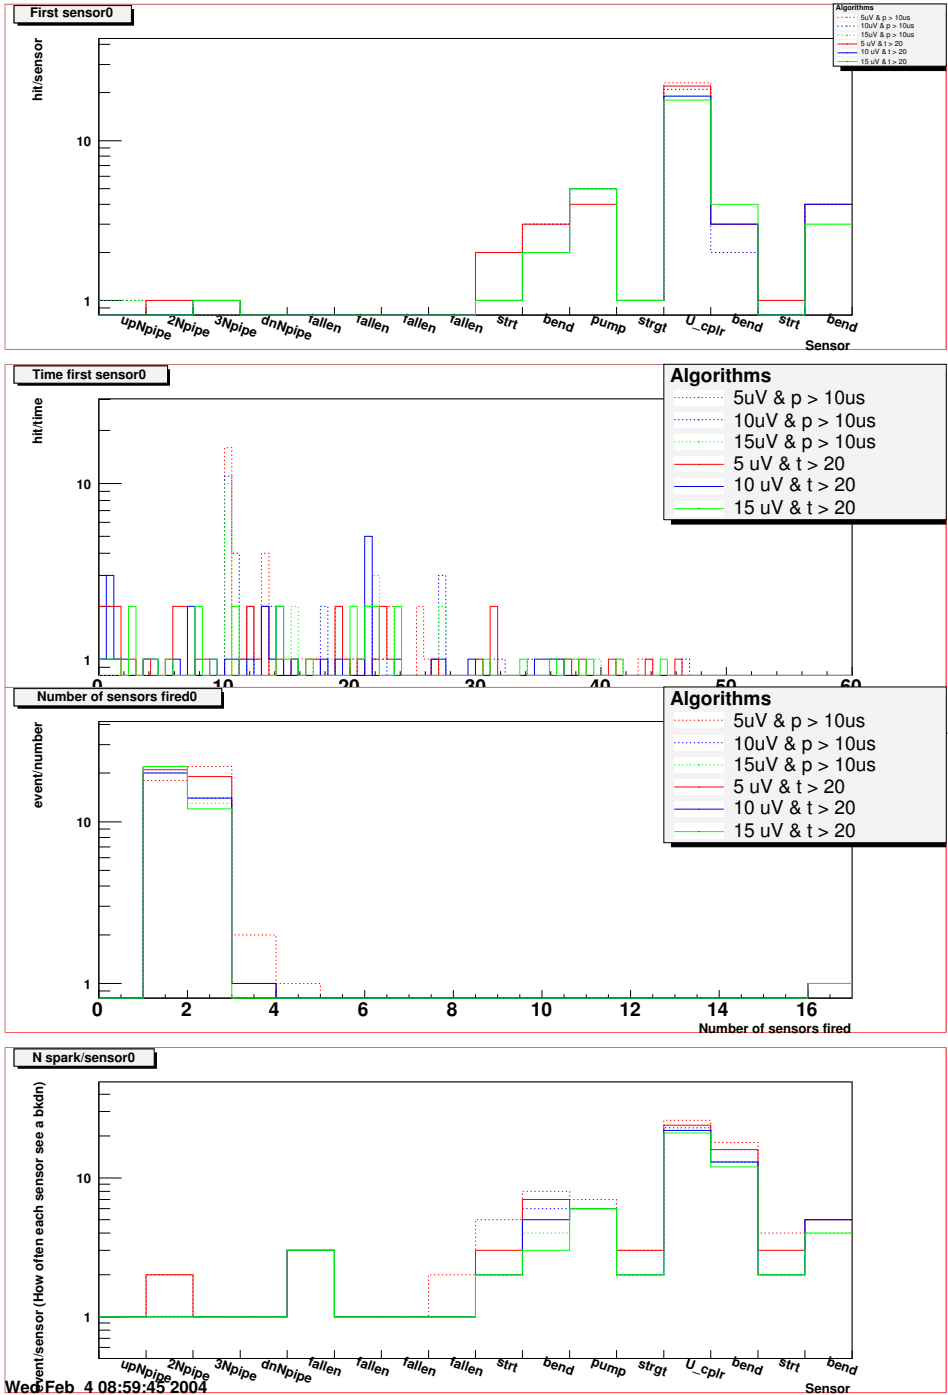
Figure 16: X-band analysis. All sensors used for this analysis were installed on waveguide components. The different colors correspond to different breakdown threshold. Dashed line correspond to simple breakdown and plain line to long breakdowns.

The statistical repartition of the breakdowns following this classification can be seen on figures 16 and 17.

These two figures correspond to different configuration of the acoustic sensors. Figure 16 uses data where all sensors were located on the waveguides. Some of them were located on straight section of the pipes whereas some other were located on bends or on a coupler. As one can expect most of the breakdowns where recorded near the bent waveguides and near the coupler. Half of these sensors were moved for the data used by figure 17. Those sensors have been relocated at the end of the accelerating structure, another location where many breakdowns (but also a lot of noise) were expected. The location of the beakdowns on that figure is conform to the expectations.

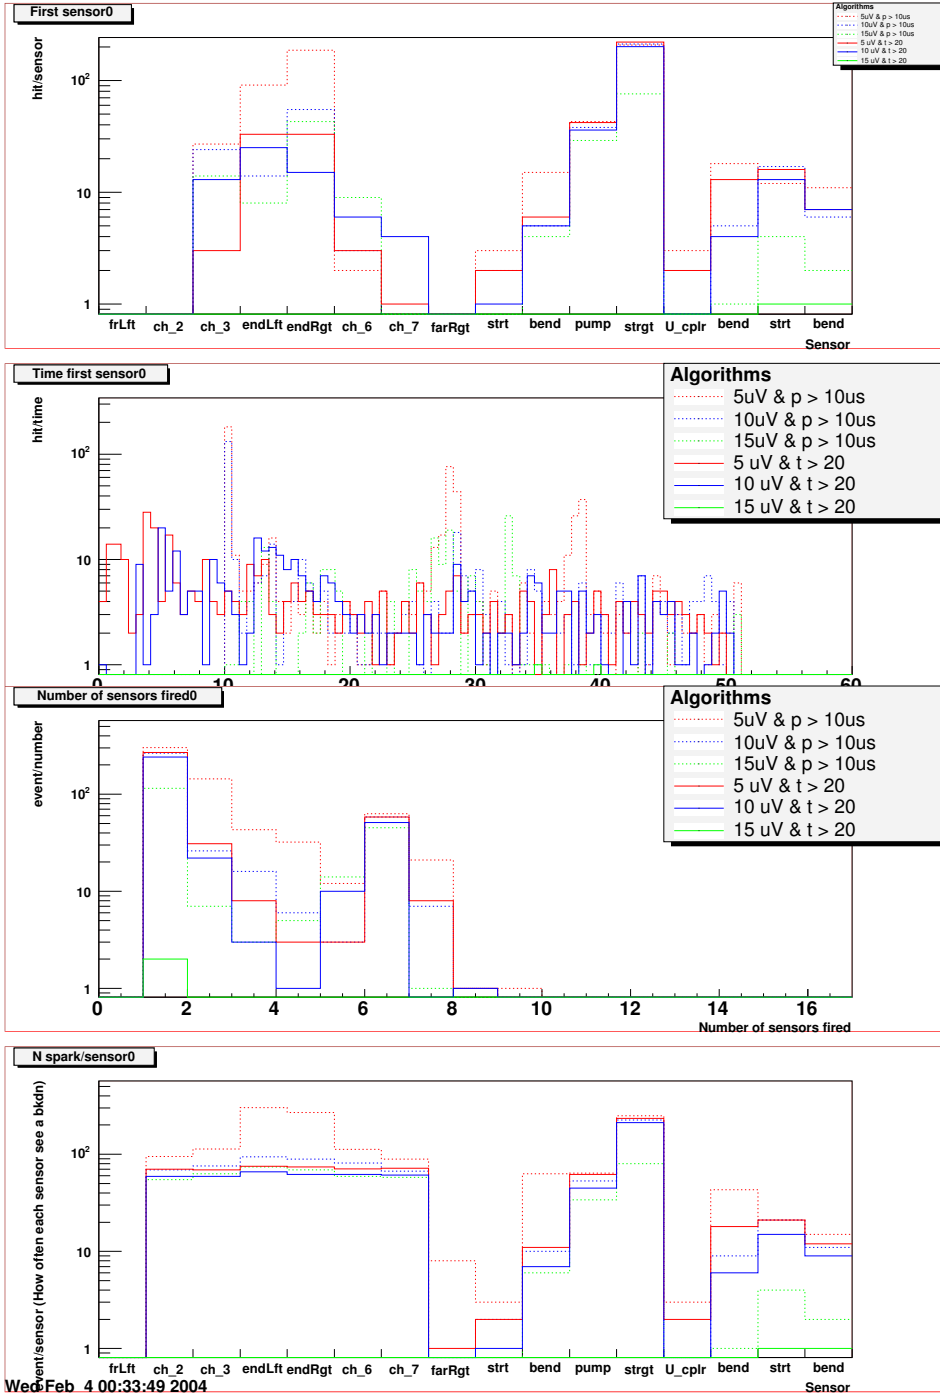
Figure 17: X-band analysis. Half of this sensors used for this analysis were installed on waveguide components and the other half were installed at the exit of the accelerating structure. The different colors correspond to different breakdown threshold. Dashed line correspond to simple breakdown and plain line to long breakdowns.
